Delamination of plasters applied to historical masonry walls: analysis by acoustic emission technique and numerical model

A Grazzini^{1,2}, G Lacidogna¹, S Valente¹ and F Accornero¹

Abstract. Masonry walls of historical buildings are subject to rising damp effects due to capillary or rain infiltrations, which in the time produce decay and delamination of historical plasters. In the restoration of masonry buildings, the plaster detachment frequently occurs because of mechanical incompatibility in repair mortar. An innovative laboratory procedure is described for test mechanical adhesion of new repair mortars. Compression static tests were carried out on composite specimens stone block-repair mortar, which specific geometry can test the de-bonding process of mortar in adherence with a stone masonry structure. The acoustic emission (AE) technique was employed for estimating the amount of energy released from fracture propagation in adherence surface between mortar and stone. A numerical simulation was elaborated based on the cohesive crack model. The evolution of detachment process of mortar in a coupled stone brick-mortar system was analysed by triangulation of AE signals, which ca

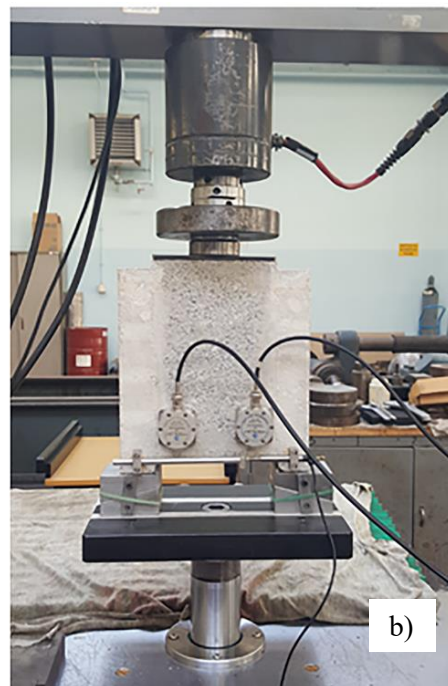
For carrying out tests, a particular geometry of the composite specimen has been proposed. Four mixed specimens were made, applying a 40 mm mortar layer to both shorter faces of the stone brick suitably cut with the dimensions shown in figure 2(a). The mechanical characteristics of the repair mortar and the stone brick were chosen equivalent to those of the stone masonry at the Sacro Monte di Varallo. The hydraulic lime mortar was a pre-blended transpiring product, for dehumidifying repair work on historical masonry damaged by dampness. For this mortar the Young's modulus was 7000 MPa, the compressive strength was 33.8 MPa.

Figure 2. Geometry of composite specimen (a) and test setup (b).

The surface of the stone block has been treated specifically by means of a drill to facilitate the mortar's adhesion. This treatment aimed to simulate the real discontinuities on the wall surface that favor the adhesion of the plaster. The application of the dehumidified mortar took place leaving specific and surface symmetrical discontinuities at the top and bottom of the specimen, as showed in figure 2(a). These notches favored the trigger and propagation of multiple cracks, in order to test the adhesion of two linked materials. An inductive horizontal displacement transducer was applied at the bottom of the specimen for the bulging displacements (figure 2(b)). The vertical displacements were recorded by the piston's translation of the 250 kN servo controlled test machine. The composite specimens were tested by monotonous compression load by horizontal controlled opening. Static tests have been performed after 28 days of maturation. The composite specimen rested, through the side layers mortar, on a double system of steel wedges (figure 3). The wedges were coupled by a 1 mm thick Teflon layer for reducing the horizontal friction during the plaster's expansion. The "SM" (Stone brick-Mortar) label has been associated with each specimen with its sequence number.
